Water Levels – Going UP Just Above Average For The Next 6 Months

TIA Water Levels Committee (210/23 updated) – by Barton, Stewart & White

UPDATED SUMMARY – Fall 2022 Levels Finally Crossed Above Average to Start 2023

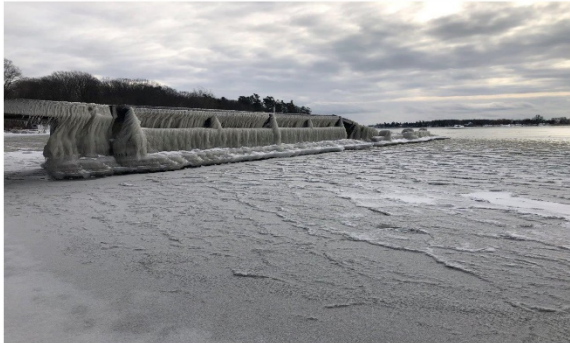
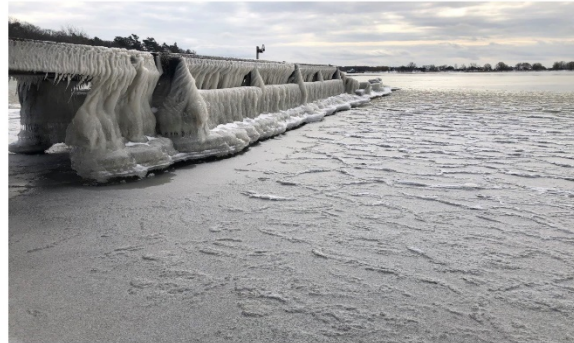
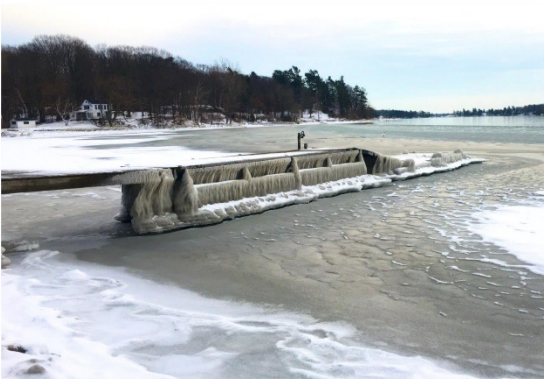
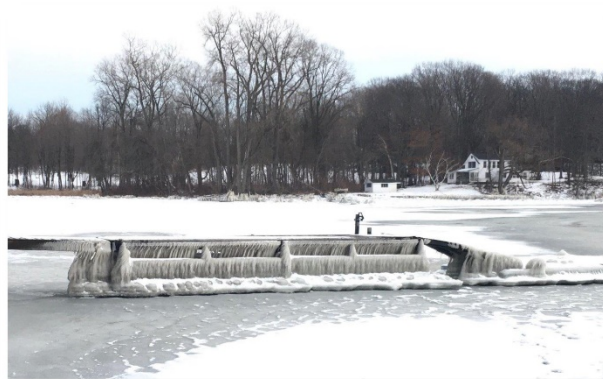
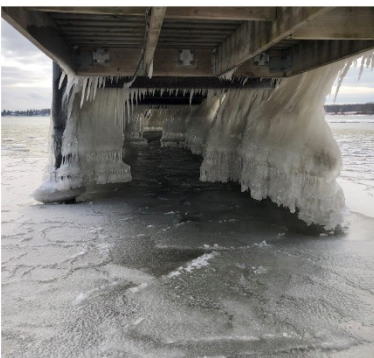
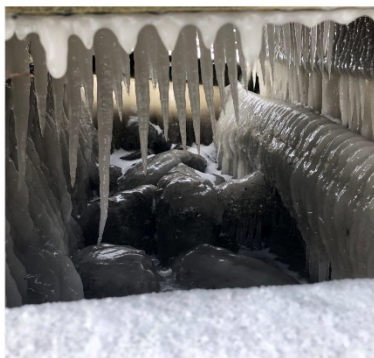
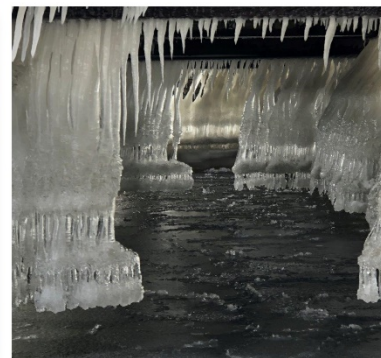
Eastern Entrance to the Bateau by Alec Turner

Alec reports that “at our dock, the Christmas Blow produced a peak wind of 91.5 kph” (56.86 mph) Given that there was practically no ice in the River, the intense winds picked up water and instantly made ice where the spray landed.

Take a look above at the icicle formations UNDER the DOCK!!

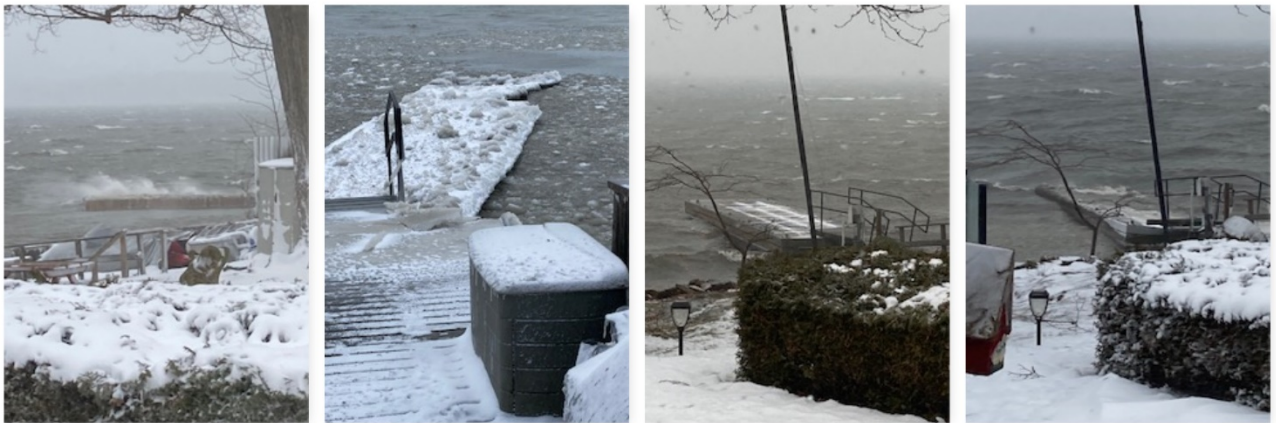
- Spray is the biggest driver of ice buildup. The spray (see below left) coming from our neighbour's fixed breakwater has now deposited at least 1 foot of solid ice on top Maybe the warm temps later in the week will melt some or most of it.

Spray visible (above left) on stationary breakwater dock

- Our 50' by 10' floating dock has at least an average of 6" of ice from the spray still frozen hard on it and pushed it lower by over 1 foot
- I figured if the 6" of ice would weight about 12500 lbs (6.25 tons), so little wonder the floating dock is low in the water. The shore is totally iced in with spray.

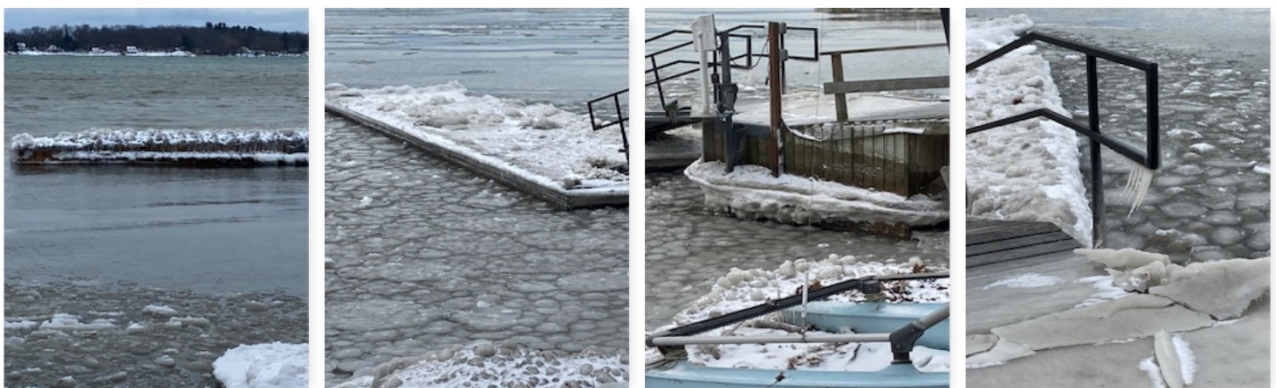
Pancake ice is an unusual phenomenon where round floating pieces of ice continue to grow. On the far right above notice all of the round pancake ice, then see the next group

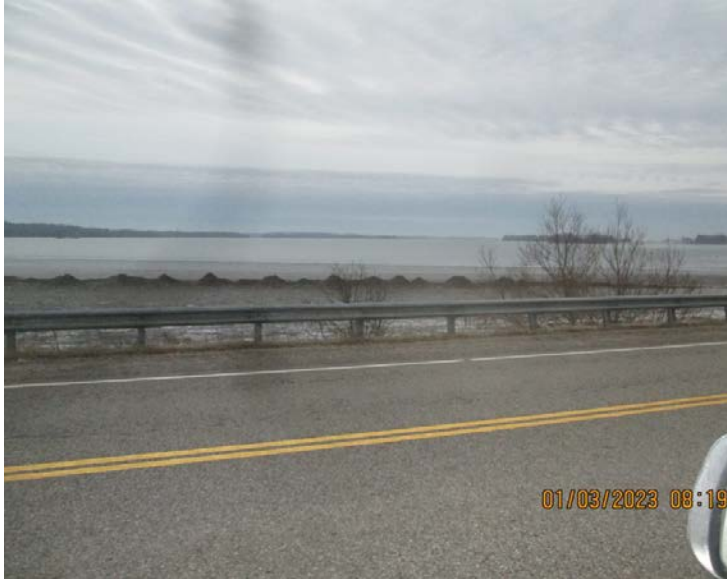
Click to enlarge [Halsteads Bay by the rest stop 230103.jpg](#)

Four rather unique images follow. The next photo, combined with the above chart is intended to help with view orientation as **Stave** and **Gordon Islands** are visible in the distance at Halsteads Bay along The Parkway.

Here's a unique photograph, shot from the Gan side of the rest stop pull-off on The Parkway, just after crossing the bridges at the entrance to Landon's Bay. The view is of Halstead's Bay with **Stave Island** on the far left and **Gordon Island** behind scrub bushes at the guardrail on the right (Jackstraw Shoal is at its SW tip).

Background: The wind was so powerful, driving huge waves into the shore (close to the guardrail), that the waves stripped the bottom and made a bumpy yet tall pile of bottom trash, weeds, minnows etc about 80 yards from the road...While it looks like an uneven 8 – 10 foot tall snowbank, it's actually a solid pile of bottom debris.

The result is a complete redefinition of the shoreline as there's no water between the long pile and the road's normal shore. It's a phenomenon totally unfamiliar to the locals, and may possibly still be there in the spring.

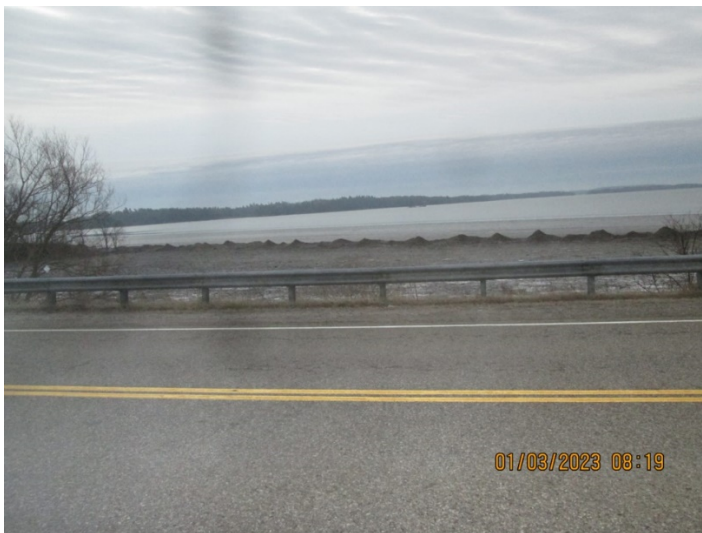
Click to enlarge [Halsteads Bay on the Gan side of rest stop 230103.jpg](#)

Mounds are 8 to 10 feet high and 30 feet out from where we used to get in the water, which is on the left near the one large tree, with **Hickey Island** directly behind it. The rest stop parking is just to the left (East) of this tree.

So why did this local shoreline devastation happen in just the area of Halstead's Bay along The 1000 Islands Parkway?

It has everything to do with the relationship of the exact wind direction and the “**reach**” of the open water with which the wind aligned. “**Reach**” is a term most familiar to our sailing friends. There is minimal interruption of the wind from Forty Acres all the way to the Halsteads Bay shore.

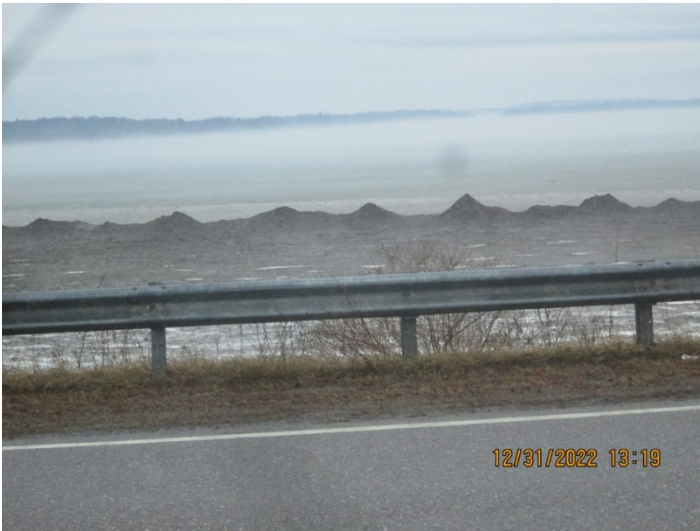
Click to enlarge [Halsteads Bay 221231 1.jpg](#)

The now dry shoreline between the edge of The Parkway and massive piles of debris can best be seen in this photograph

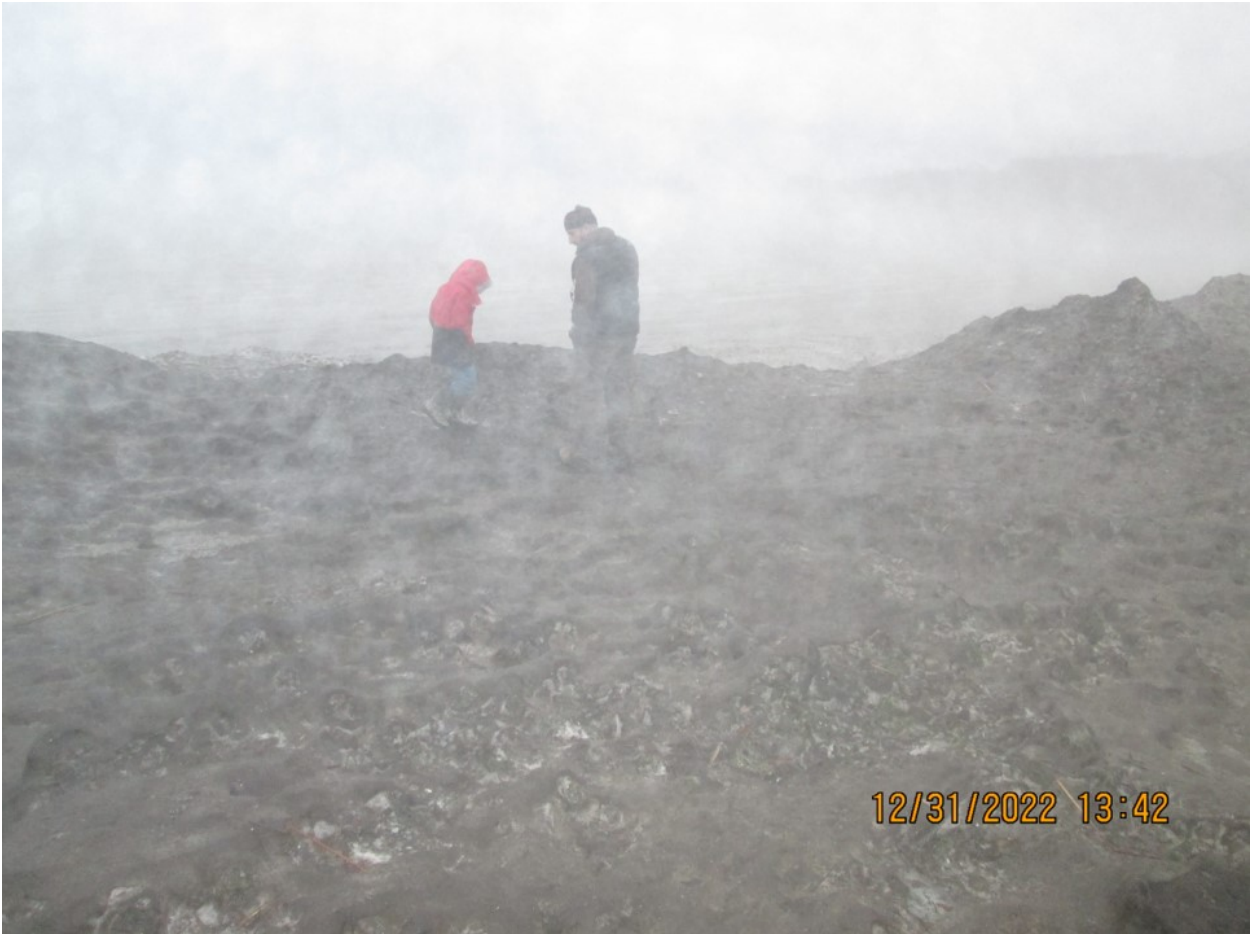
This is a small part of the long and TALL pile of bottom debris photographed from the Parkway on the foggy New Year's Eve day. The uneven mound is about 8 – 10 FEET high. *The question is whether the Halstead Bay shoreline has been altered just for the near future or long term?*

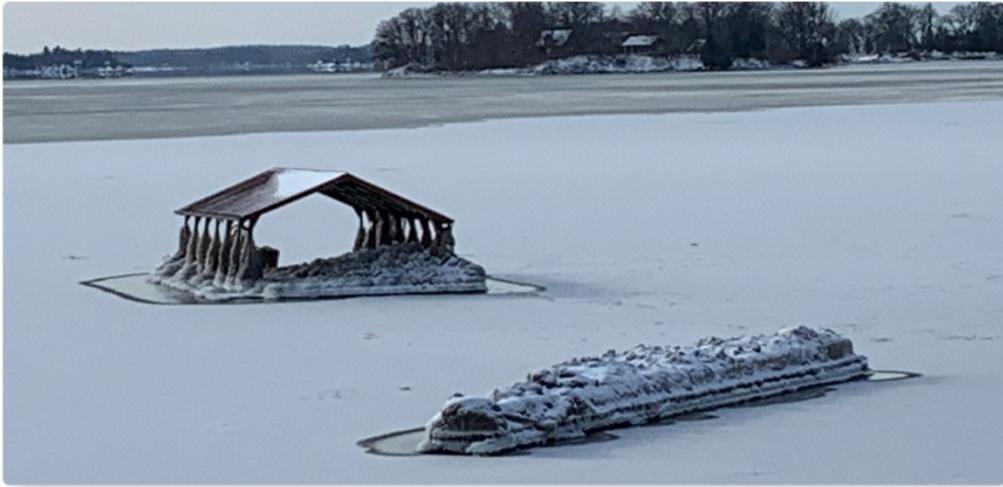
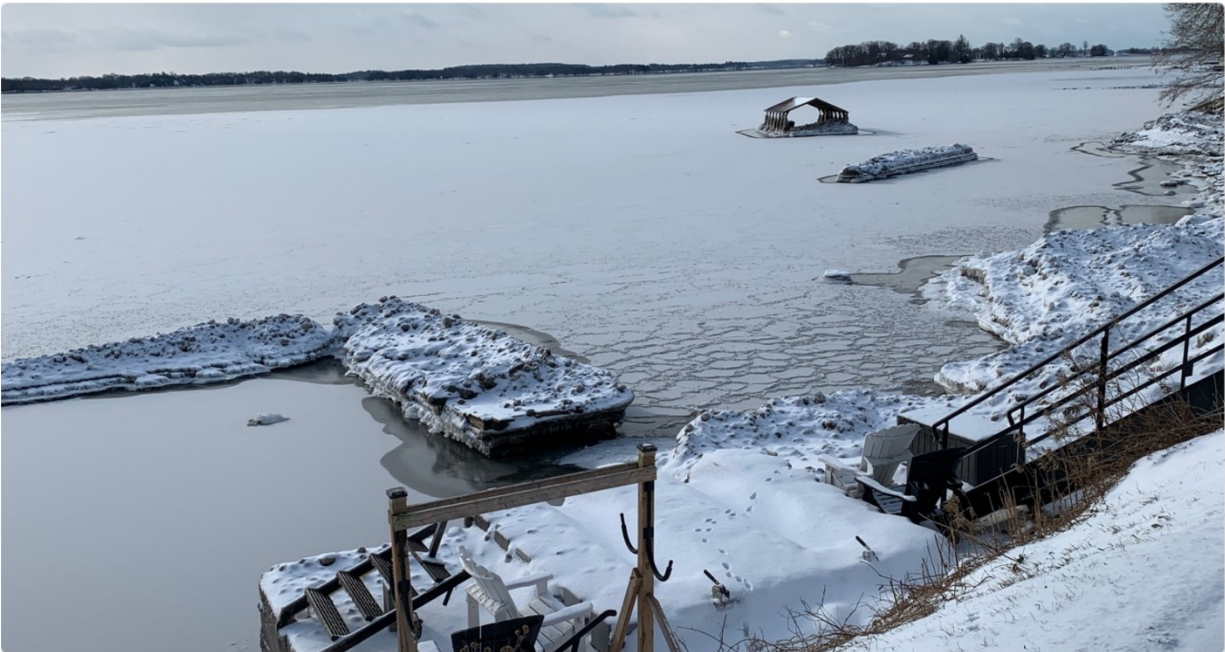
Western End of Halsteads Bay towards Gananoque – Jim Coté Photos

With a light snow cover for the recently formed skim ice, at first glance this scene looks rather peaceful, with memories of the raging Christmas Big Blow quickly fading.

These and other previous photos are a reminder of the fury which visited to kick off the Christmas holidays. The amount of ice buildup on dock and shoreline surfaces is very apparent in these images. Close examination of both photos is a reminder of the incredible force it took to totally disconnect both the large ice-filled floating boathouse and separate ice laden dock structures from their shore moorings as is shown above.

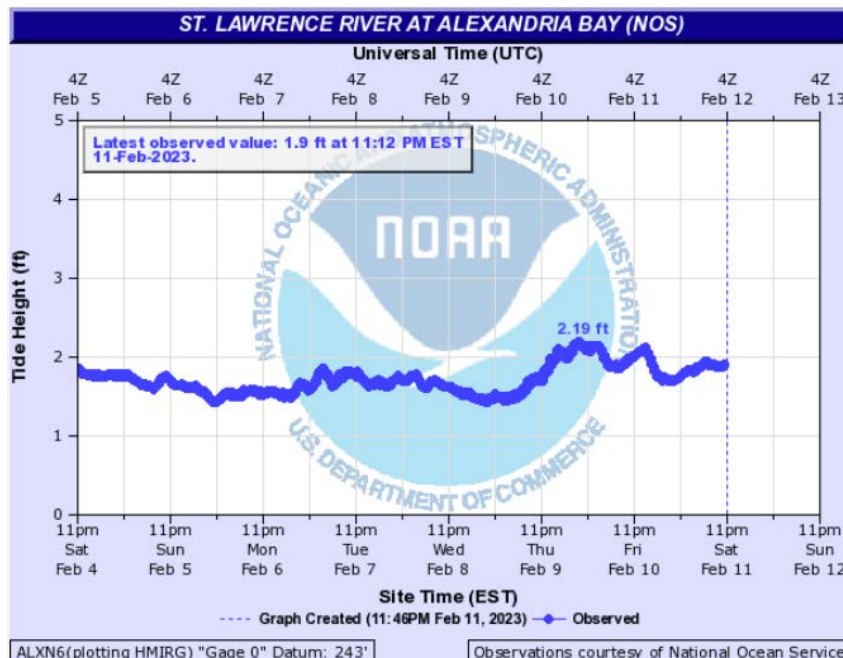
Saturday the 11th the wind from the SW continued, abating Sunday morning as the water levels “sloshed” up and down, oscillating as the River and Lake slowly settled.
